2018 BUICK ENCLAVE

#18-NA-178 - Electric Park Brake Inoperative or Service Park Brake Lamp On - (Jun 4, 2018)

Electric Park Brake Inoperative or Service Park Brake Lamp On

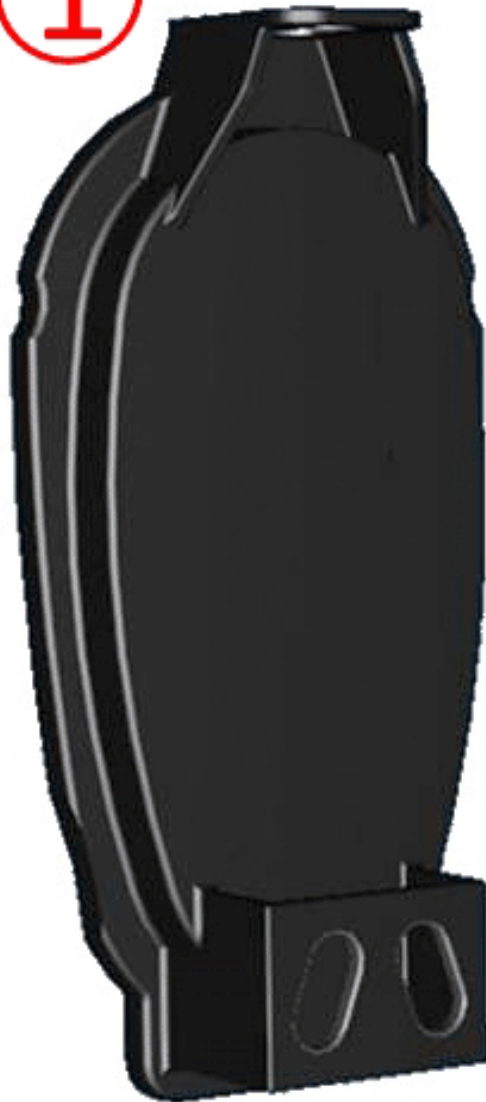
①

<ul style="list-style-type: none"> • Old cover design (1). • New cover design (2).
Correction 2	If DTC's are not set and/or the brake actuators have been previously been replaced, program the EBCM to the latest calibration available.
Correction 3	If DTCs C1587 0B or C1588 0B are set, program the EBCM to the latest calibration available.

When replacing the brake actuator. Verify that the brake actuator has the updated cover.
